NIST NCSTAR 1A

Final Report on the **Collapse of** **World Trade Center Building 7**

Final Report on the Collapse of World Trade Center Building 7

November 2008

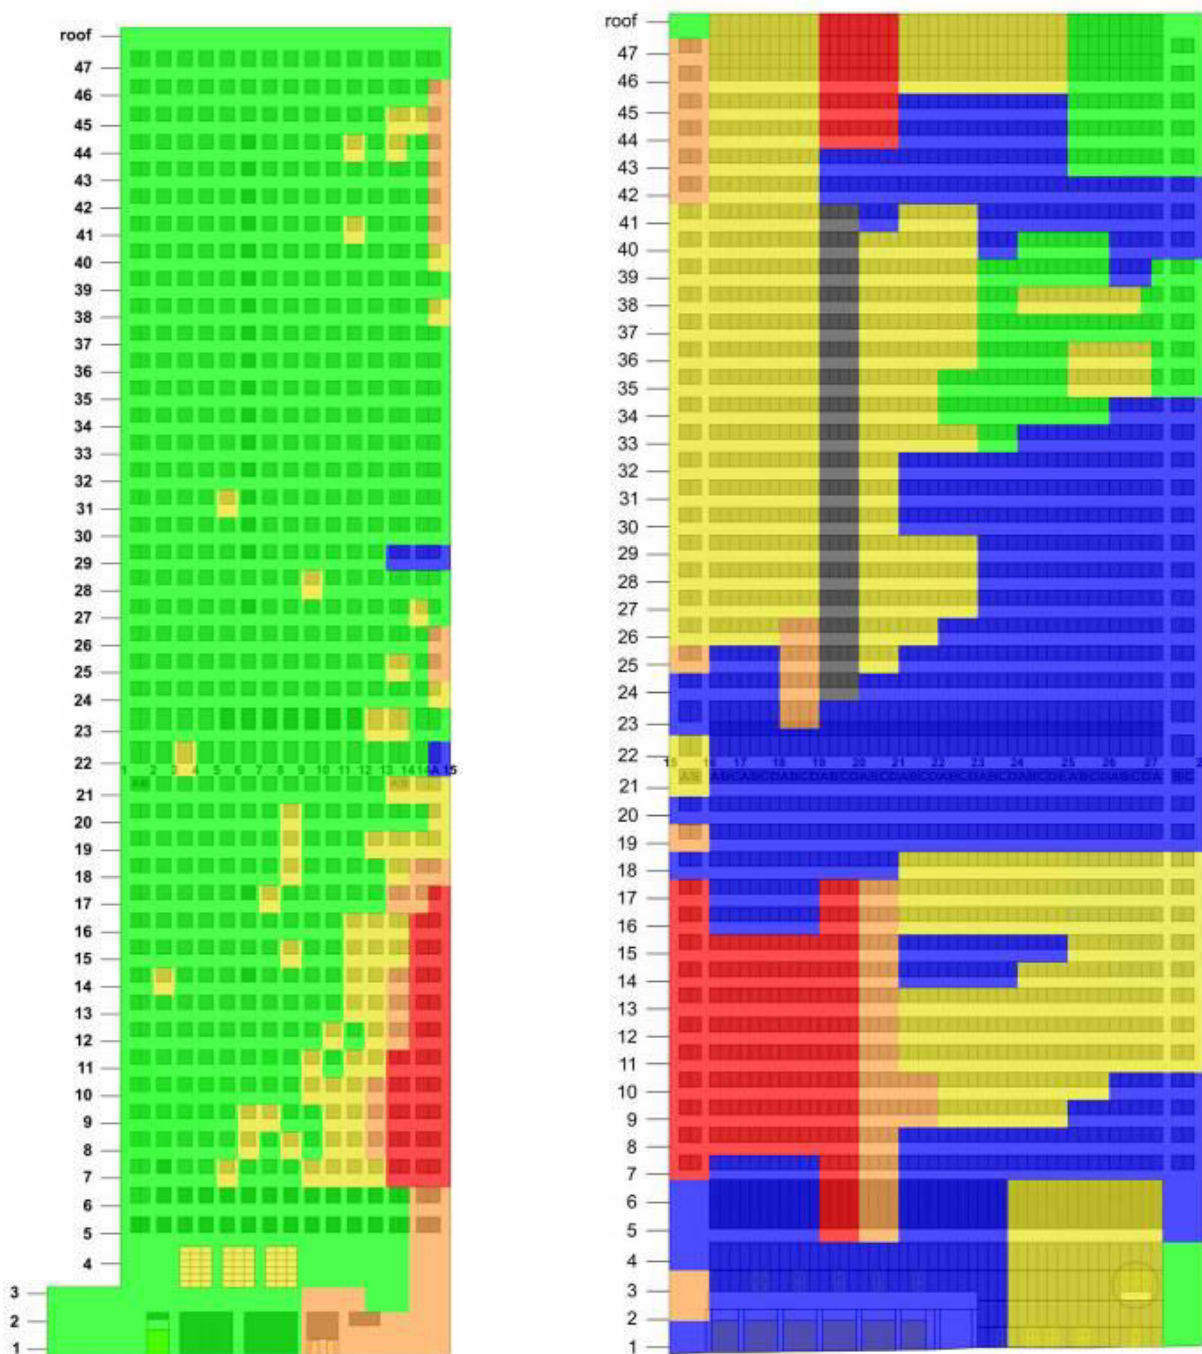
When WTC 1 collapsed at 10:28:22 a.m., most of the debris landed in an area not much larger than the original WTC 1 building footprint. However, some fragments were forcibly ejected and traveled distances up to hundreds of meters. Pieces of WTC 1 hit WTC 7, severing six columns on Floors 7 through 17 on the south face and one column on the west face near the southwest corner. The debris also caused structural damage between Floor 44 and the roof. The damage to the building face is depicted in Figure 2–1. Based on photographic evidence, witness accounts, and engineering judgment, it is likely that the structural damage (steel and floor slabs) did not penetrate beyond the perimeter of the building core. At the southwest corner, the structural damage extended only about one-third of the distance from the exterior wall to the building core. The debris also broke a large number of windows on the south face. Compared to the airplane impact damage to the WTC towers, there was relatively little damage to the interior of WTC 7. For instance, damage to the sprayed fire resistive material (SFRM) was limited to the immediate vicinity of the WTC 1 debris impact. There was no superficial or structural damage to the north and east faces (NIST NCSTAR 1-9, Chapter 5, Section 5.5.2).

Figure 2-1. Observed damage to WTC 7 following the collapse of WTC 1.
West face (left) and south face (right)

The damage is color coded as follows: green (■)- no visible damage, yellow (■) – window glass broken, orange (■) – granite and underlying truss damage, red (■) – damage to exterior structural steel, gray (■) – possible structural damage, and blue (■) – not visible due to smoke, dust, and intervening buildings.

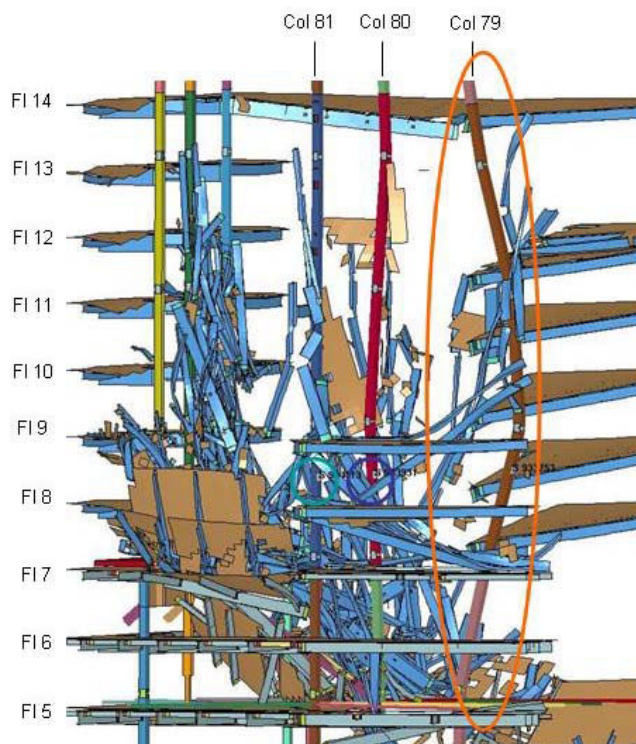
Fire-induced thermal expansion of the floor system surrounding Column 79 led to the collapse of Floor 13, which triggered a cascade of floor failures. In this case, the floor beams on the east side of the building expanded enough that they pushed the girder spanning between Columns 79 and 44 to the west on the 13th floor. (See Figure 1–5 for column numbering and the locations of girders and beams.) This movement was enough for the girder to walk off of its support at Column 79.

The unsupported girder and other local fire-induced damage caused Floor 13 to collapse, beginning a cascade of floor failures down to the 5th floor (which, as noted in Section 1.2.3, was much thicker and stronger). Many of these floors had already been at least partially weakened by the fires in the vicinity of Column 79. This left Column 79 with insufficient lateral support, and as a consequence, the column buckled eastward, becoming the initial local failure for collapse initiation.

Figure 2–2. Eastward buckling of Column 79, viewed from the southeast.

Due to the buckling of Column 79 between Floors 5 and 14, the upper section of Column 79 began to descend. The downward movement of Column 79 led to the observed kink in the east penthouse, and its subsequent descent. The cascading failures of the lower floors surrounding Column 79 led to increased unsupported length in, falling debris impact on, and loads being re-distributed to adjacent columns; and Column 80 and then Column 81 buckled as well. All the floor connections to these three columns, as well as to the exterior columns, failed, and the floors fell on the east side of the building. The exterior façade on the east quarter of the building was just a hollow shell.

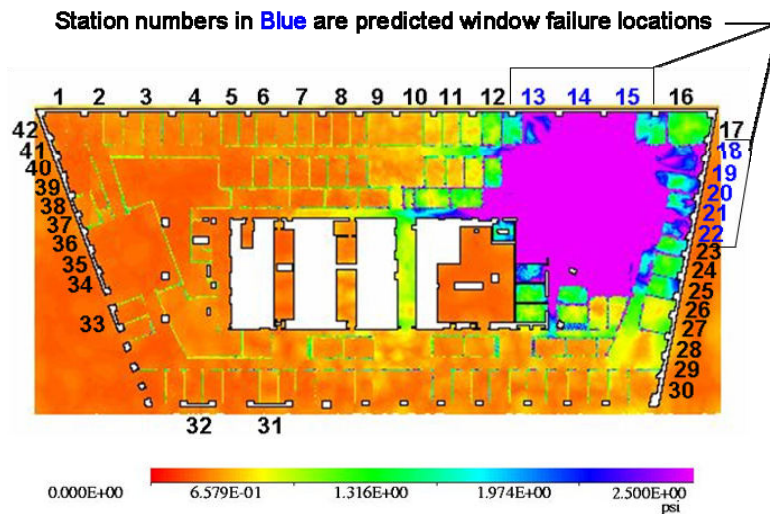
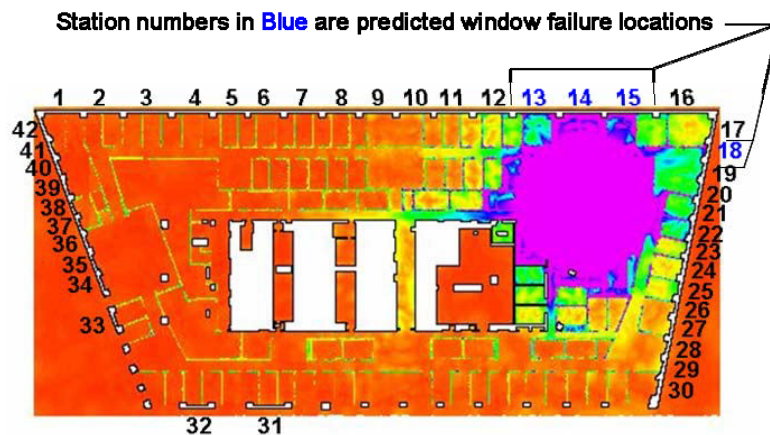
Figure 3–1 shows the results for the two shaped charges applied to Column 79 on a tenant floor that was highly partitioned, such as Floor 12. Nearly all the windows on the northeast section of the floor subjected to a blast would have been broken, even by the smaller charge. Simulations for a floor that was not highly partitioned led to more extensive window breakage.

Figure 3–1. Peak overpressure and broken window locations.

Top: 9 lb shaped charge; bottom: 2 lb charge.

The actual window breakage pattern on the visible floors on September 11, 2001 (NIST NCSTAR 1-9, Chapter 5) was not at all like that expected from a blast that was even 20 percent of that needed to damage a critical column in WTC 7. The visual evidence did not show such a breakage pattern on any floor of WTC 7 as late as about 4:00 p.m. or above the 25th floor at the time of the building collapse initiation. Views of the northeast corner of WTC 7 at the time of the collapse were obstructed by other buildings.

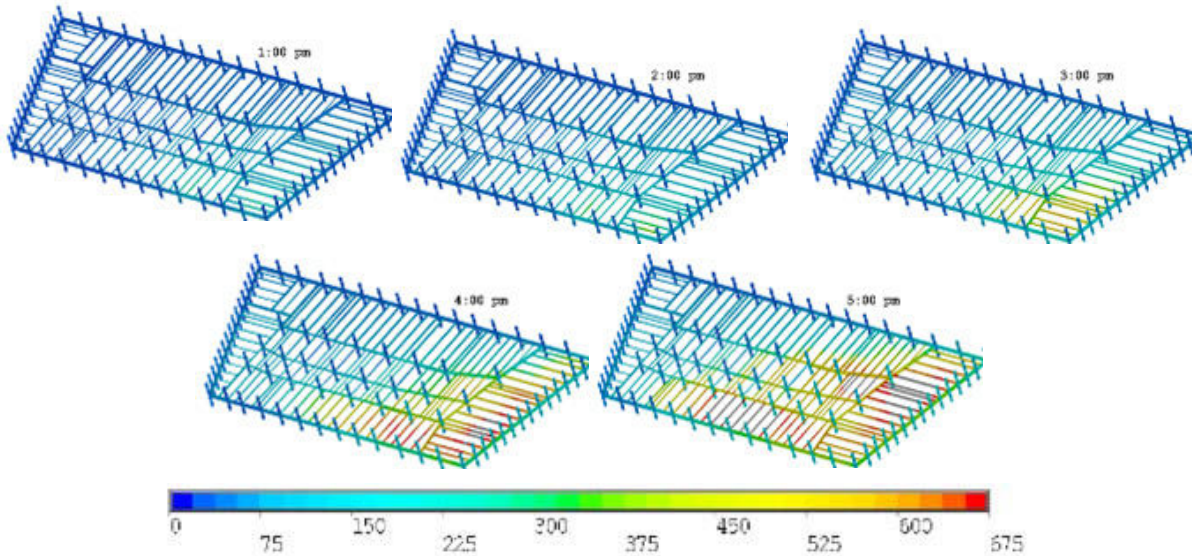
Figure 3–7 shows the calculated heating of the structural steel on the lower 16 floors of WTC 7 for the Case B temperatures from the fire simulation. The floor slabs have been removed from the figure for clarity. Figure 3–8 is a typical rendition of the calculated heating of the top of a floor slab as a result of the Case B fire.

Figure 3–7. Computed temperature distribution (°C) of Floor 13 steel framing at five different instants in time.

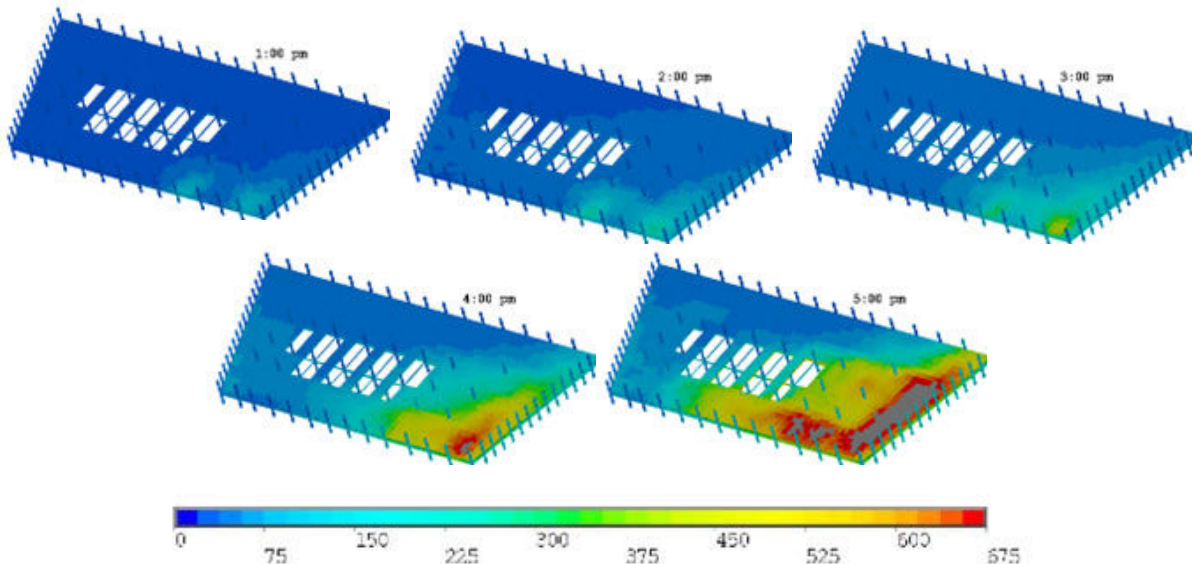
Figure 3–8. Computed temperature distribution (°C) in the top layer of the concrete slab of Floor 12 at five different instants in time.

Grey shading indicates temperatures >675 °C

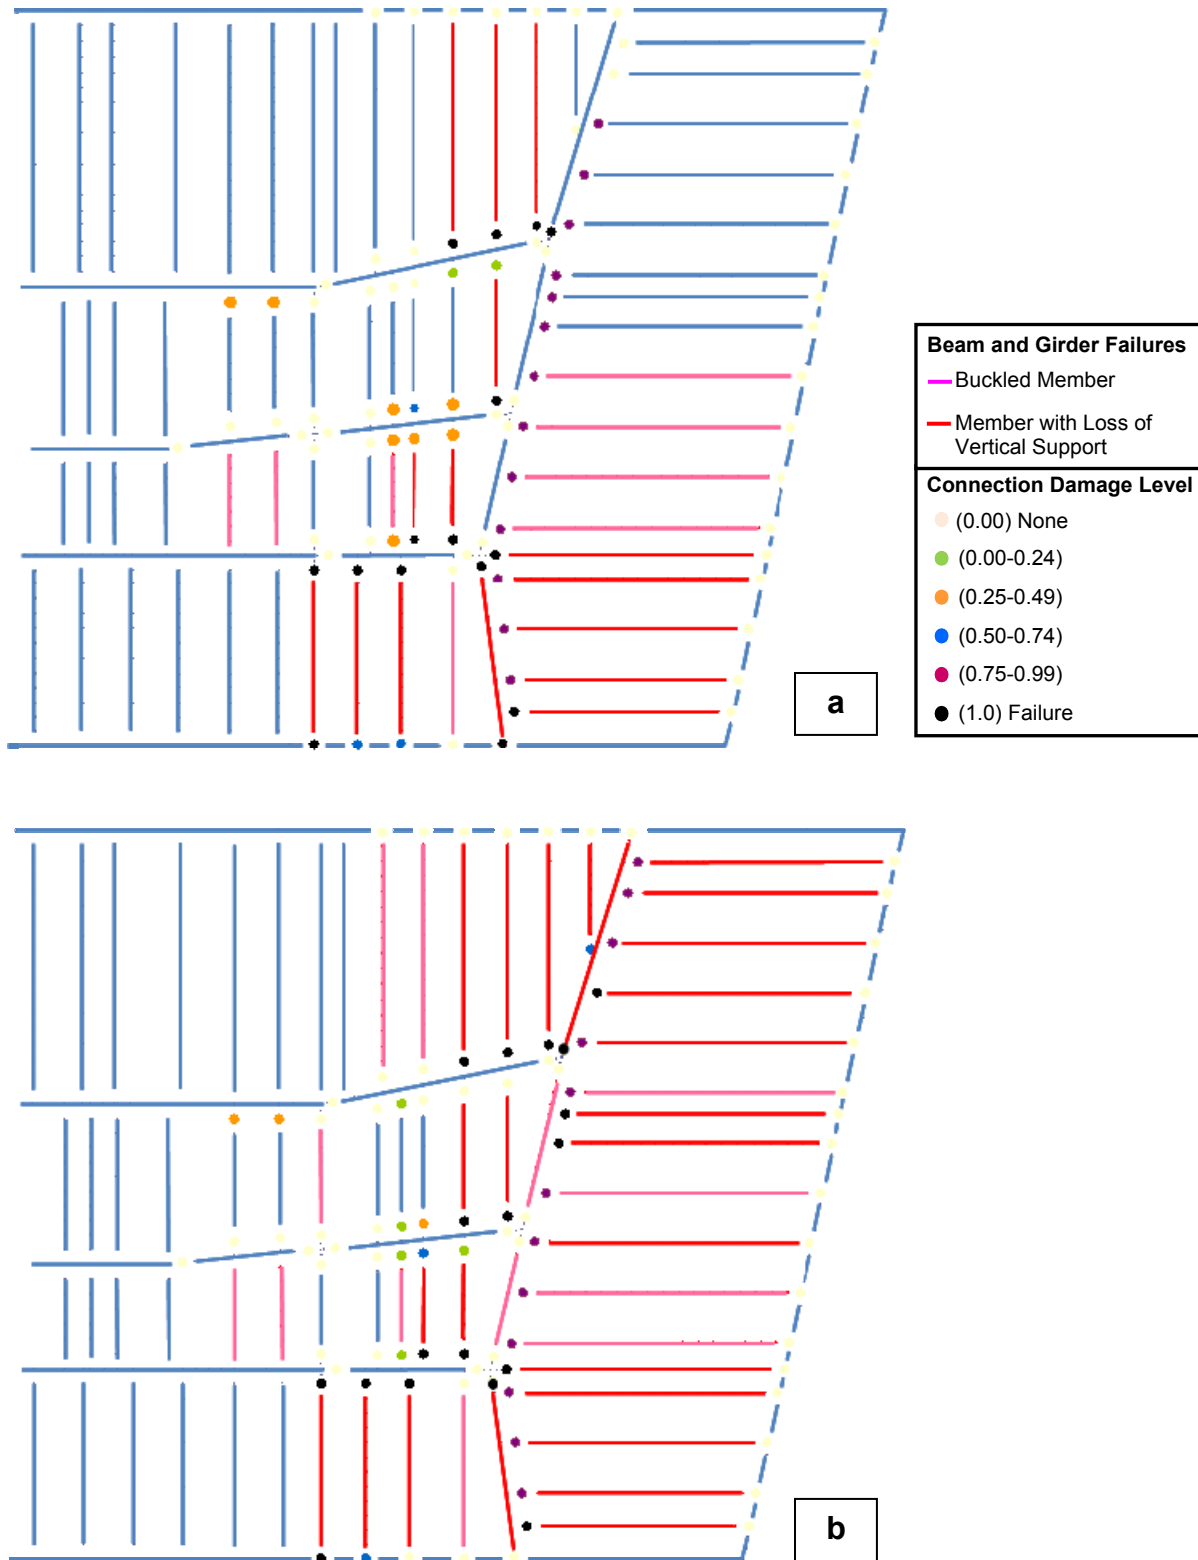
The ANSYS results were input to the LS-DYNA analysis when it appeared that an initial failure event might be imminent. Damage diagrams for the 16 floors modeled in ANSYS, such as those shown in Figure 3–9, indicated some degree of uncertainty in selecting the time and damage state for the transition. However, it appeared likely the critical damage state occurred between 3.5 h and 4 h. Accordingly, as shown in the next section, LS-DYNA analyses were performed for both of these damage states.

Figure 3–9. Damage state of connections in Floor 13 for Case B temperatures.
a: at 3.5 h; b: at 4.0 h

The second LS-DYNA analysis (lesser degree of fire-induced damage) did not lead to a collapse-initiating event, despite the extensive damage shown in Figure 3-9a.

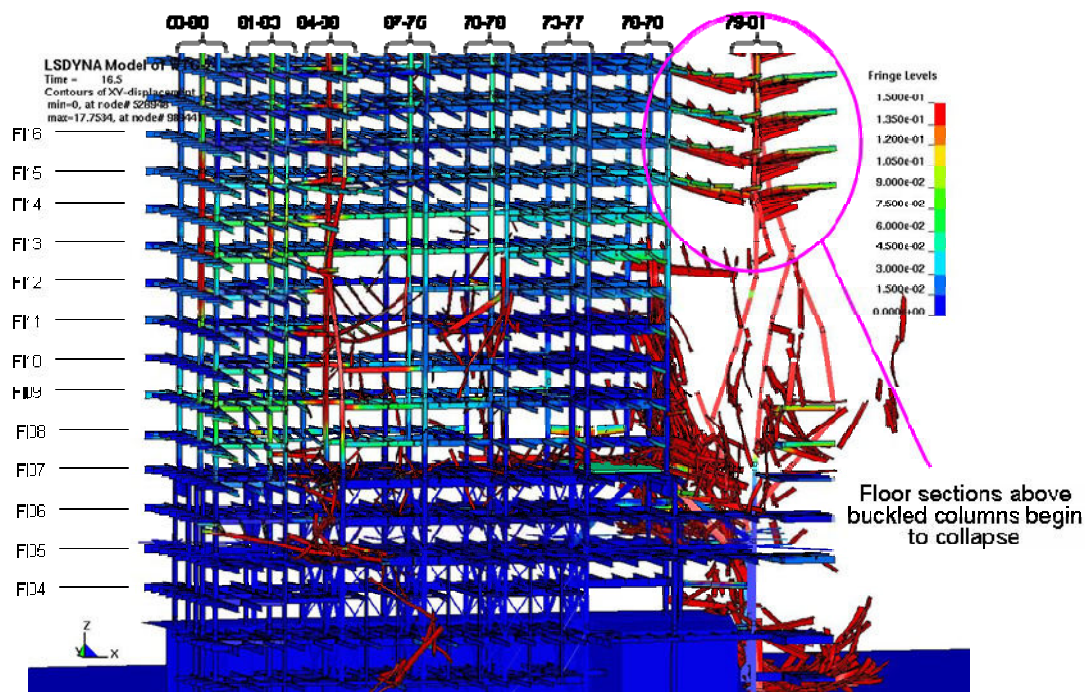
Figure 3–10. Vertical progression of failures on the east side of the building at 0.5 s following the initiation of the collapse.

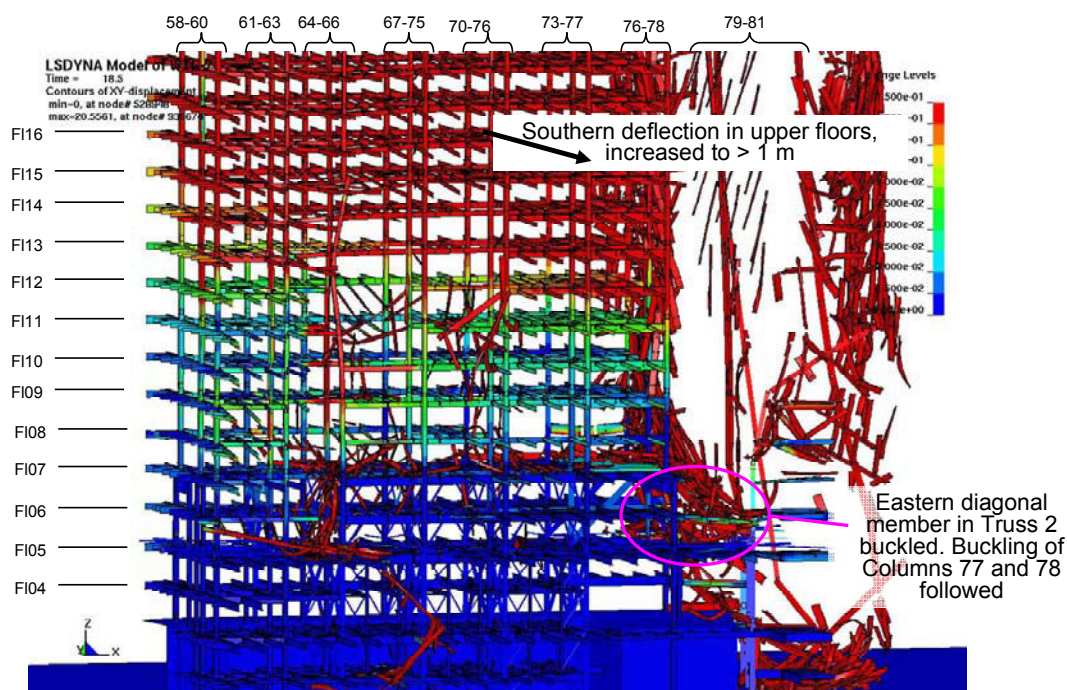
Figure 3–11. Failure of Columns 77 and 78 due to failure of Truss 2 fails from debris impact at 2.5 s following the initiation of the collapse.

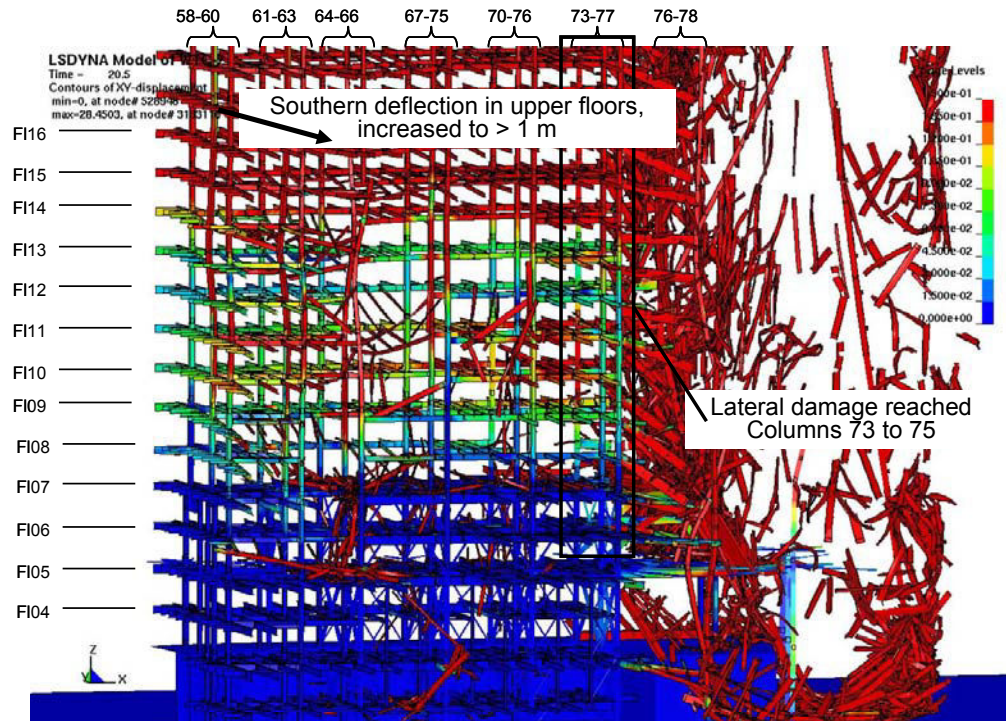
Figure 3-12. Failure of Columns 73 to 75 from the load redistribution and debris impact at 4.5 s following the initiation of the collapse.

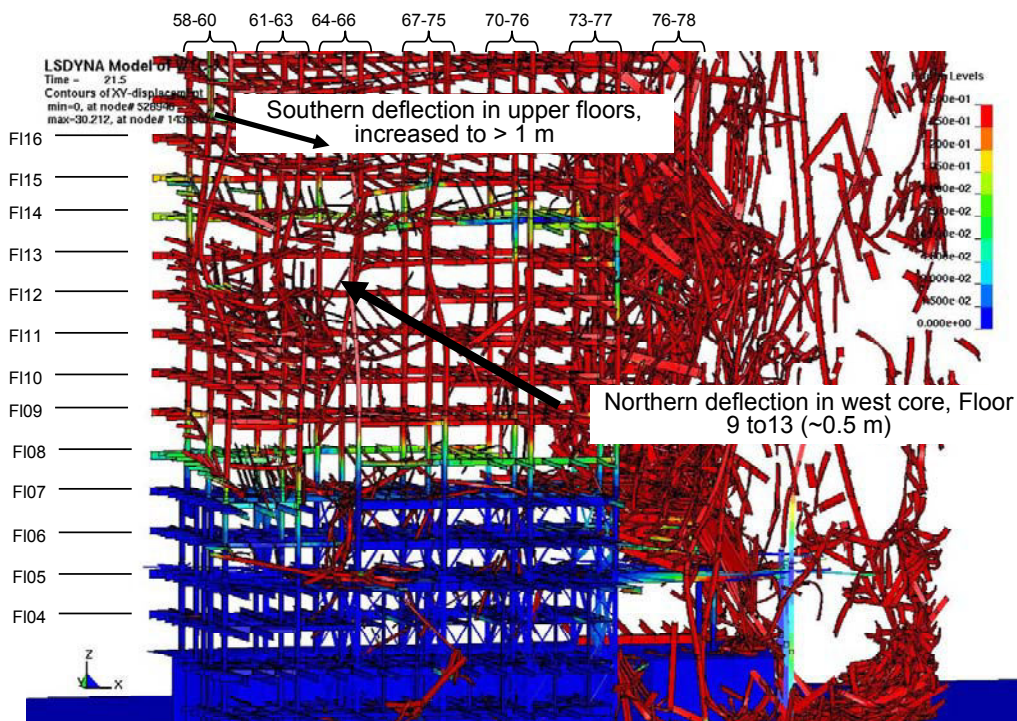
Figure 3-13. Buckling of all interior columns at 6.5 s following the initiation of the collapse.

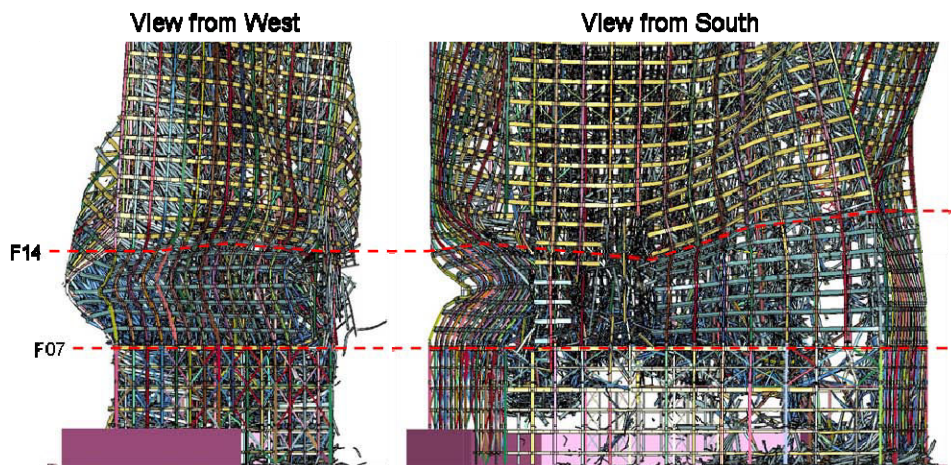
Figure 3-14. Buckling of the lower exterior columns within 1 s of Figure 3-13.
